BLUE GIANT MEADOW DAM

NDI ID ~~NO~~ - PA-00564
DER ID ~~NO~~ - 40-80

**PHASE I INSPECTION REPORT
NATIONAL DAM INSPECTION PROGRAM**

APRIL 1981

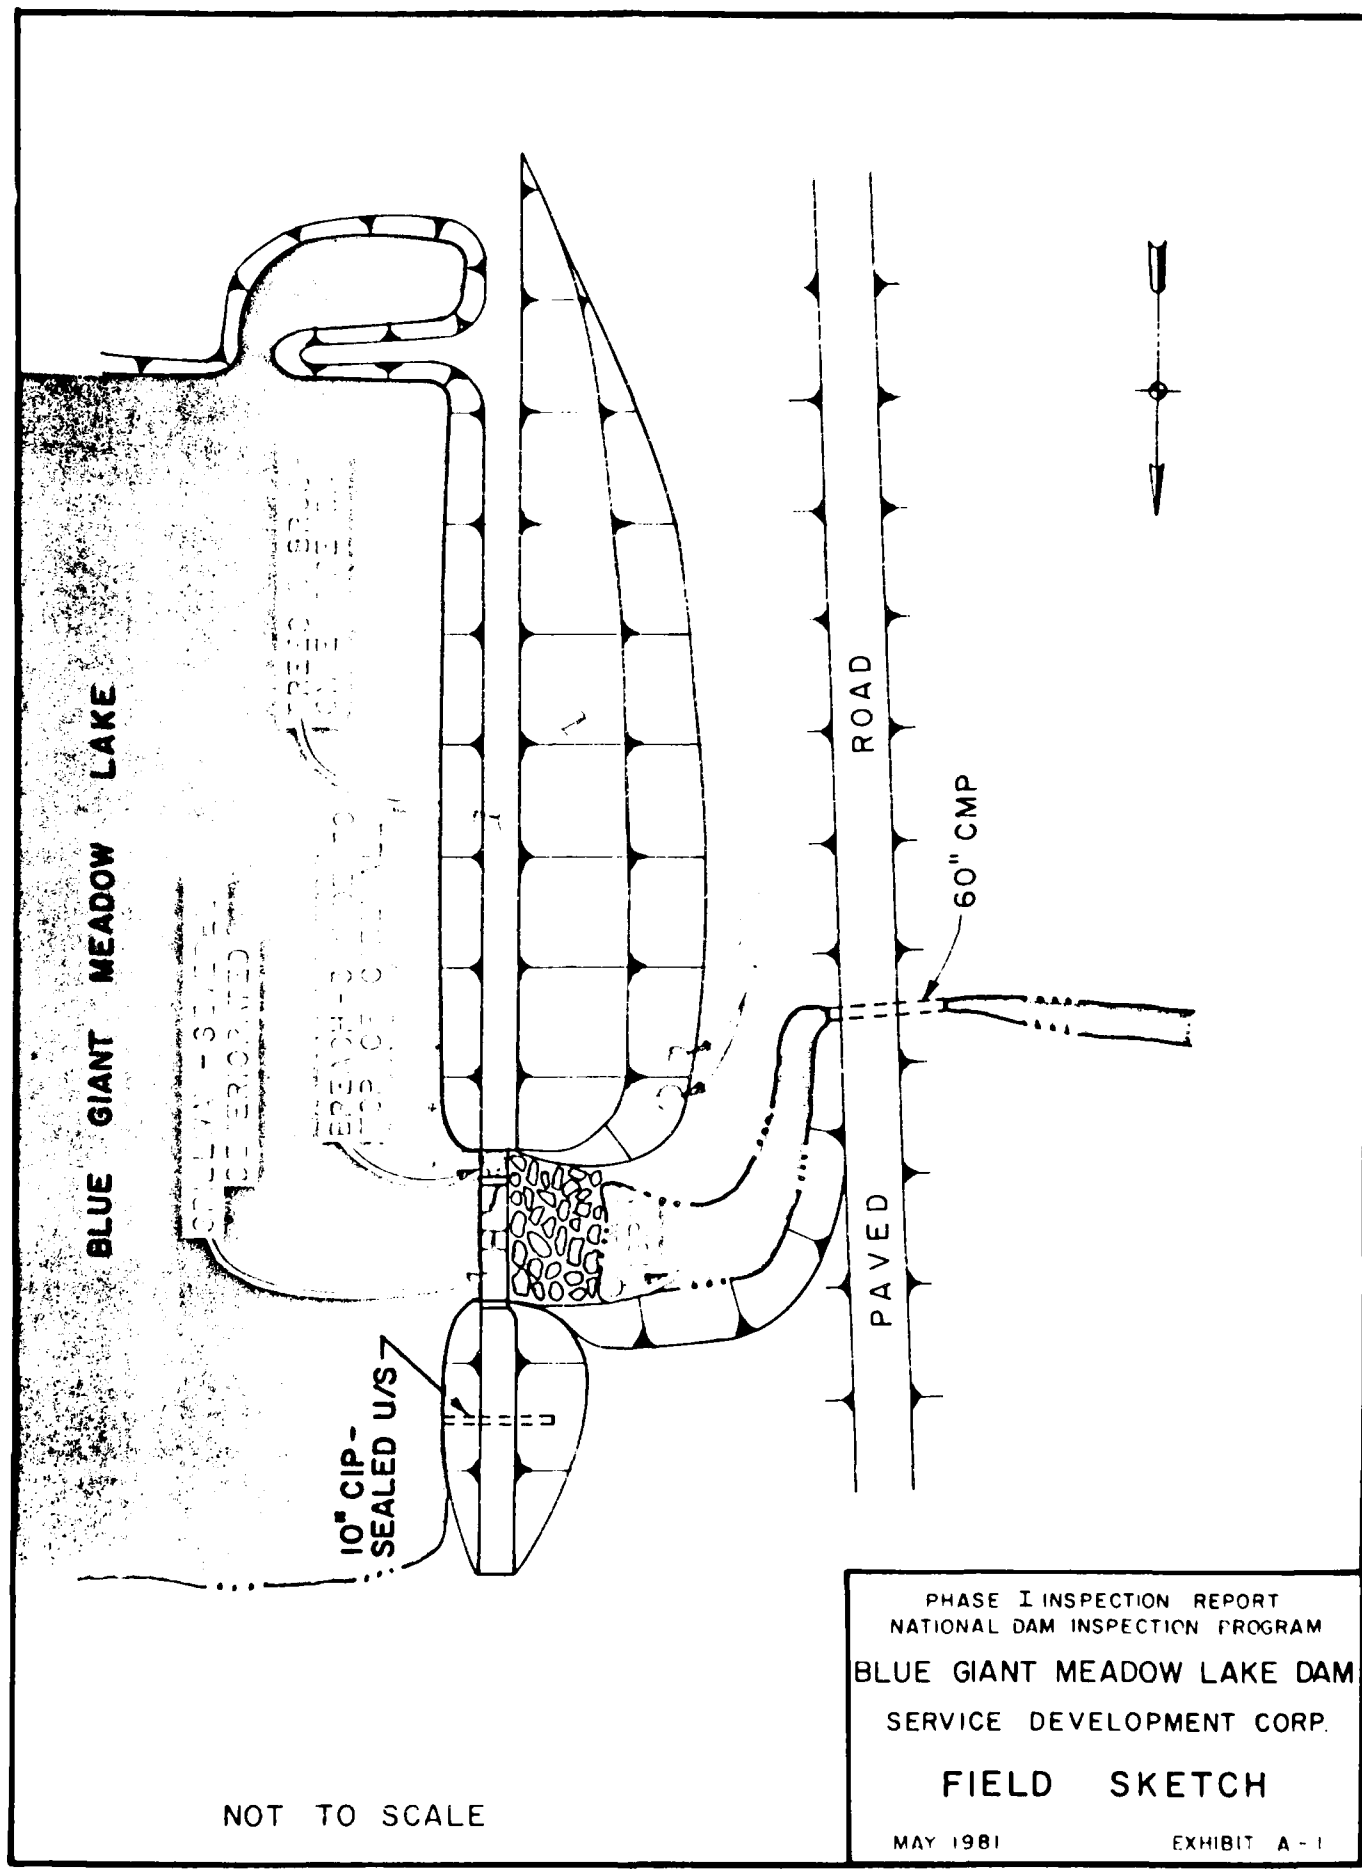
PHASE I INSPECTION REPORT
NATIONAL DAM INSPECTION PROGRAM
BLUE GIANT MEADOW LAKE DAM
SERVICE DEVELOPMENT CORP.
FIELD SKETCH
MAY 1981 EXHIBIT A - 1

VISUAL EXAMINATION OF	OBSERVATIONS
Any noticeable seepage	About 1 gpm near toe of spillway; clear
Junction of Embankment With: Abutments Spillway	Abutment junctions good. Low spots adjacent to spillway walls eroded to top of corewall
Surface Cracks	None observed; excessive vegetation made thorough inspection impossible
Crest Alignment: Vertical Horizontal	Low spot adjacent to left spillway wall. Also low at right wall. Elsewhere rising toward abutments Horizontal - Good
Unusual Movement or Cracking at or Beyond the Toe	None. Variable slope & vegetation made inspection difficult

VISUAL EXAMINATION OF	OBSERVATIONS
Outlet Works	None apparent. Original rock culvert through spillway not found. 10 inch C.I.P plugged u/s.
Spillway Approach Channel	Reservoir; clear
Spillway Crest	Concrete surface deteriorating; top 6" gone in some areas. 2' wide x 4' deep breach through crest; plugged by 8" thick concrete. Walls being undercut and flanked.
Bridge and Piers	None
Discharge Channel	Rock pile on d/s side of crest; then earth lined. No spillway walls d/s of crest.

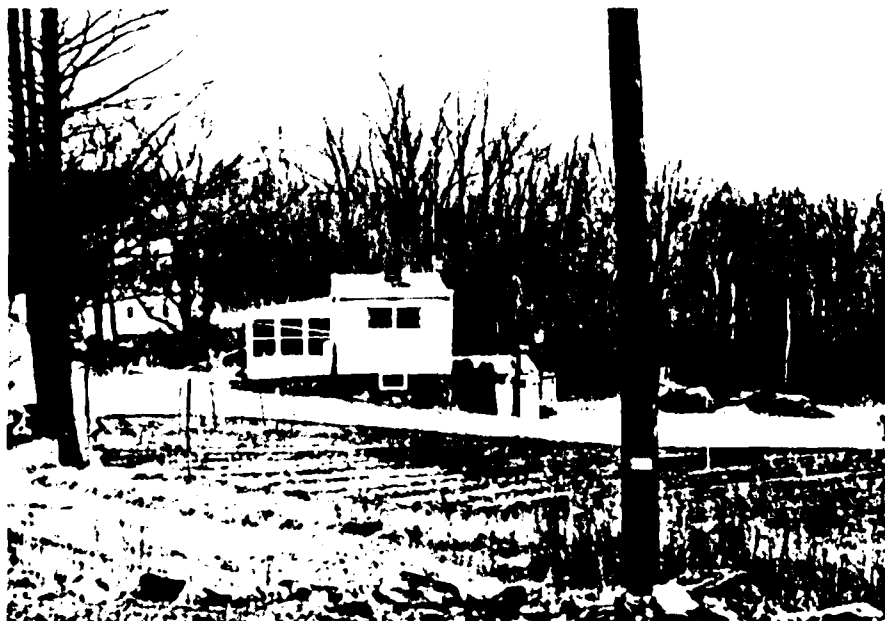
12. Downstream hazard.

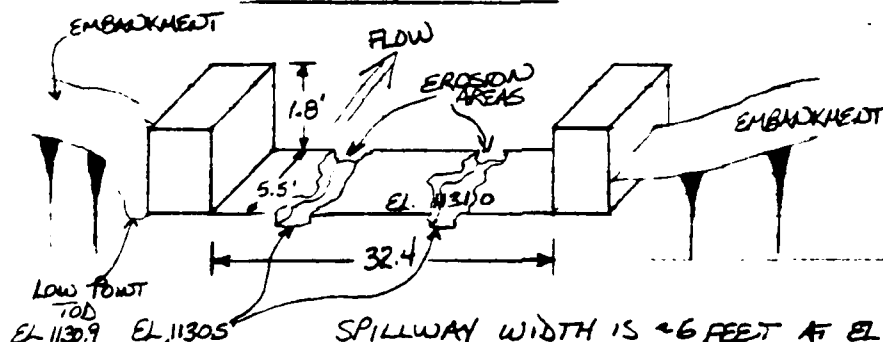
SPILLWAY SKETCH:

SPILLWAY WIDTH IS ~ 6 FEET AT EL. 1130.5 WITH 0.4 FEET FREEBOARD PRIOR TO OVERTOPPING LOW POINT OF EMBANKMENT. AT ELEVATION 1130.9, SPILLWAY WIDTH IS ORIGINAL VALUE OF 32.4 FEET PRIOR TO EROSION IN CONCRETE PAD.

NOTE: SEE PHOTOGRAPHS IN APPENDIX C. THESE EROSION CHANNELS HAVE CREATED A LOW FLOW NOTCH IN THE SPILLWAY.
